Vol. IV

No. 322

REPORT OF STATIC TEST OF SKI FOR AN SE-5 AIRPLANE

Prepared by Engineering Division, Air Service
McCook Field, Dayton, Ohio
October 3, 1921

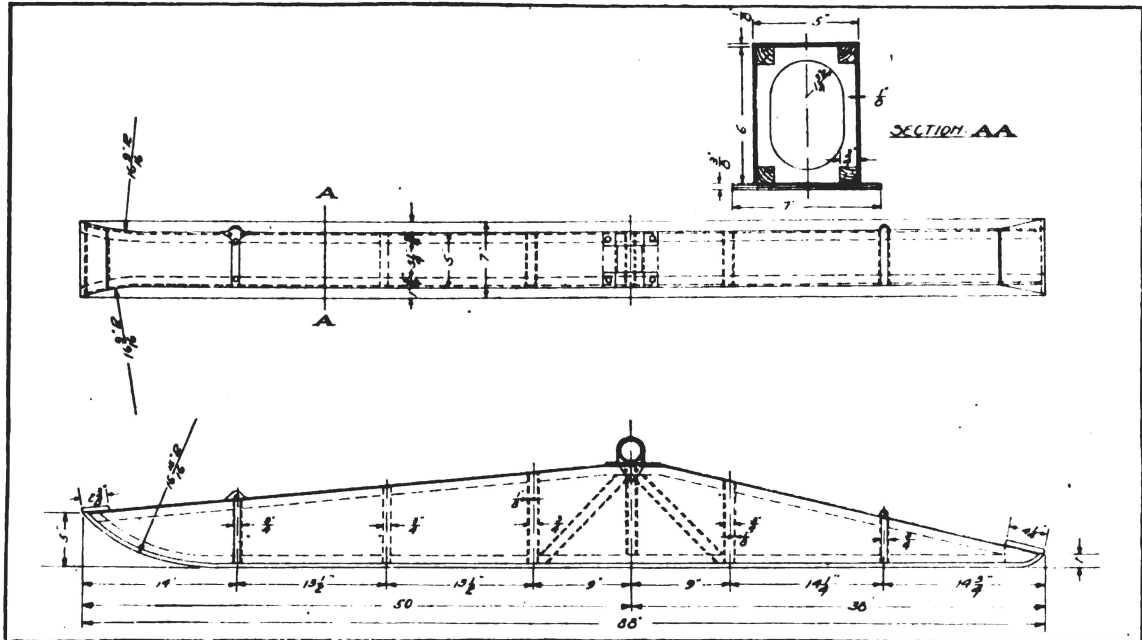
FIG. 1.—Landing ski for an SE-5 airplane.

Figure 1 shows a cross-sectional view of the ski. The weight of the ski ready for use is $21\frac{1}{2}$ pounds.
